## CASE STUDY:

# WATERMAIN PROTECTION

GRASSTREE/CAMPWIN BEACH, MACKAY, QLD  
SEPTEMBER 2017

CLIENT: MACKAY REGIONAL COUNCIL  
CONTRACTOR: HABER EXCAVATIONS

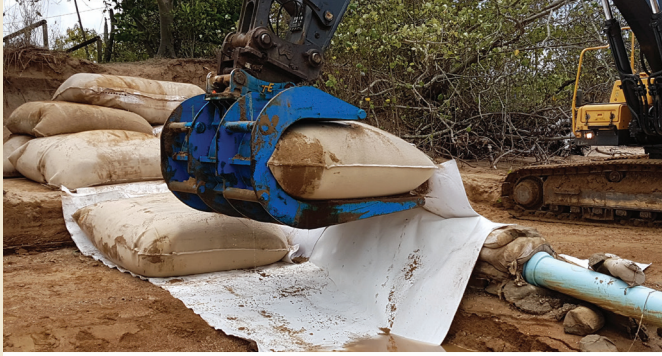
**Taking care**

The contractor on the project took great care installing the Elcorock containers to ensure the watermain was not damaged

Haber Excavations were the chosen contractor who utilised several excavators to fill and place the containers. Geofabric's staff were in attendance in the initial stages to support the contractor. Extreme care had to be taken when placing the containers alongside the conduit to ensure it wasn't damaged as the watermain remained live and is the only source of water to the Campwin Beach community. The project consumed 60 x 2.5 m<sup>3</sup> bags and 60 m<sup>2</sup> of Texcel 1200R.

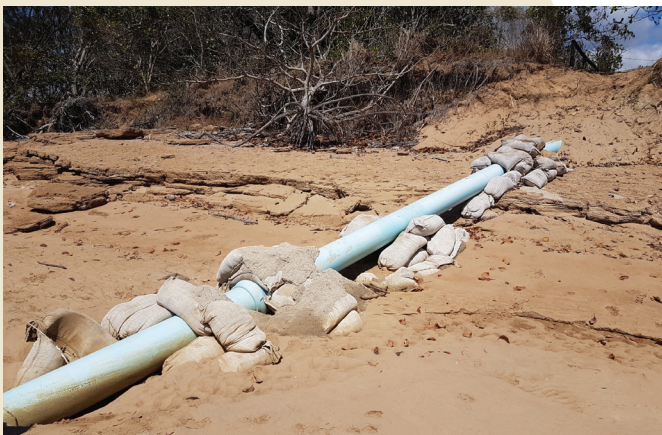
**Prone to vandalism**

The pipe ran under the mouth of an Estuary then emerged on the beach near the hamlet of Campwin Beach. The abnormal tidal conditions triggered by Cyclone Debbie severely under scoured the pipe leaving it elevated some 1-2 metres above the beach making it a tempting target for vandals.

In some sections the watermain was 1 m above the beach, making a tempting target for vandals and accidental damage

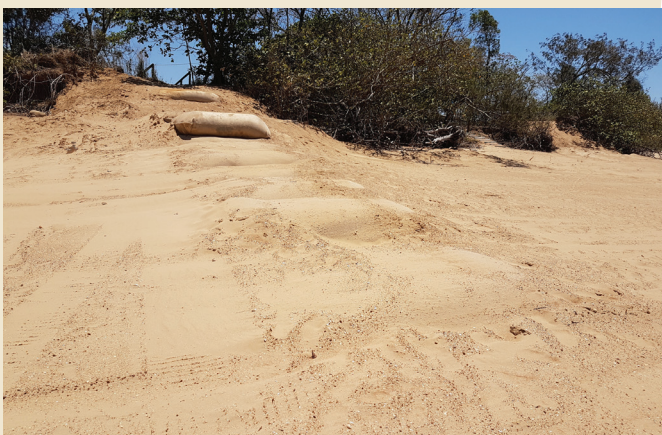
**After**

Following installation of the Elcorock solution the watermain is no longer visible

Coastal engineers were engaged to ratify the concept and provide a formal certified design to Council. 2.5 m<sup>3</sup> Elcorock sand containers were the obvious choice. The watermain conduit would be supported with a bedding of indurated material wrapped in a layer of Texcel 600R and encased in Elcorock containers.
