CASE STUDY

Project: Cameron Town Road Slip Repair
Date: June 2011
Client: Waikato District Council
Location: Pukekohe

Miragrid GX Geogrid

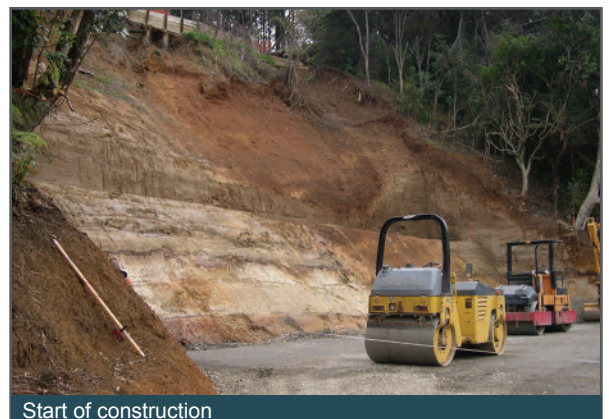
Start of construction

A 20m high geogrid reinforced steep slope was designed in conjunction with piling of 7m deep timber poles along the toe of the slope to improve global stability. Assistance during both the design and construction phase was provided by Geofabrics. **Miragrid GX** polyester geogrids were used as the primary reinforcement for the slope. **Miragrid GX** geogrids met the engineers technical requirements for the project and also offered the contractor the benefit of using a wide roll with cost savings through quick and easy installation with minimal wastage.

A five man crew and 2 diggers were able to install approximately 90m² of the face area per day. This included laying of the geogrids, placing and compaction of structural back fill material.

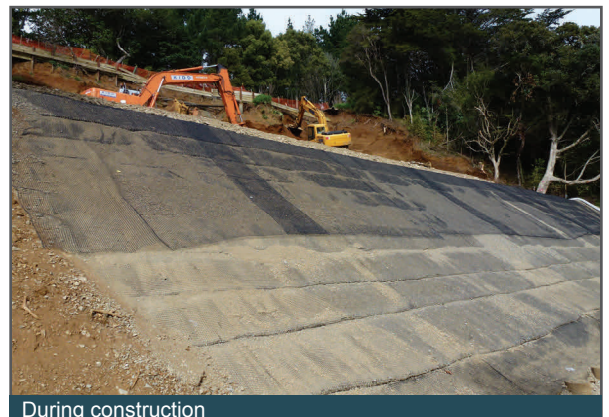
During construction

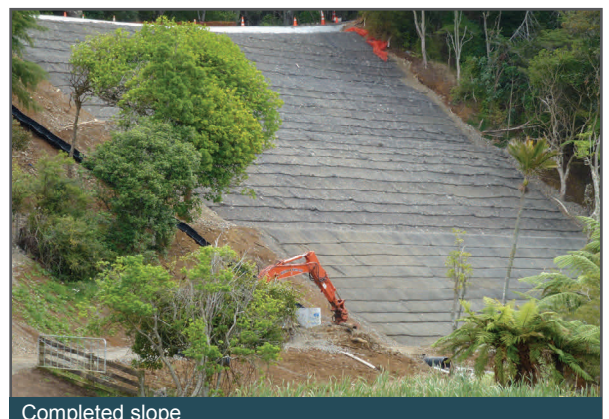
Completed slope
