CASE STUDY: **TANK LEAK DETECTION**

**COAL SEAM GAS
MINING BRINE WASTE TANK
REMOTE AUSTRALIA
JUNE 2017**

bidim C Conductive Geotextile

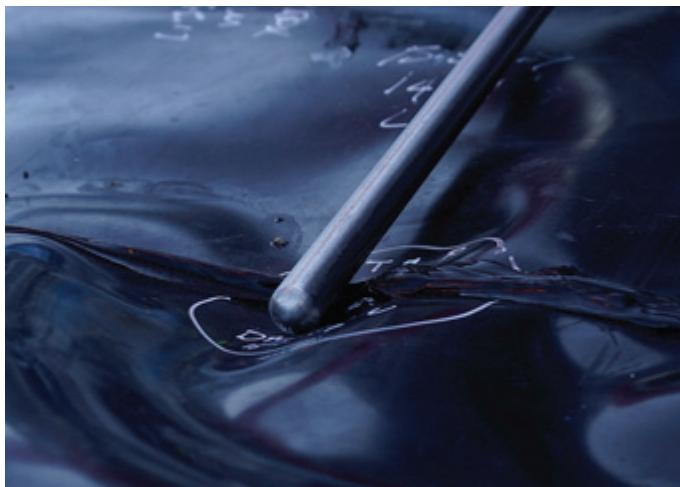
ELECTRICAL INSPECTION

Electrical spark testing of the primary liner using bidim C

The testing organisation conducted two leak detection tests on the tanks: one to the secondary liner which was tested using the traditional wetting methods and copper wires one to the primary liner using bidim C conductive geotextile.

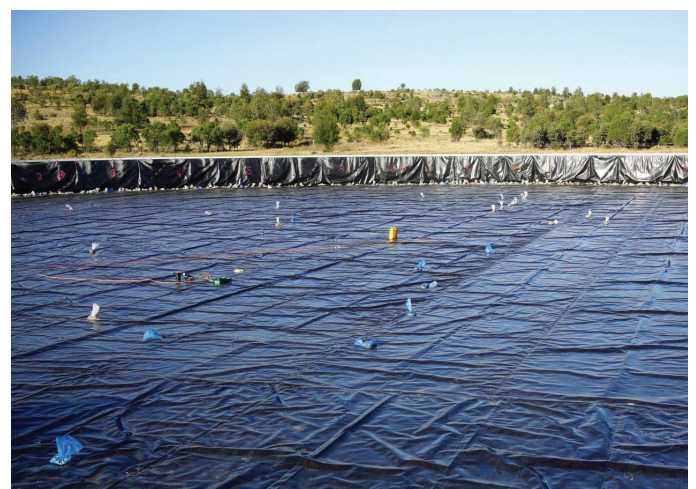
INSTALLATION OF THE PRIMARY LINER

The primary liner was installed in large prefabricated panels which were lifted over the tank walls and placed in position.

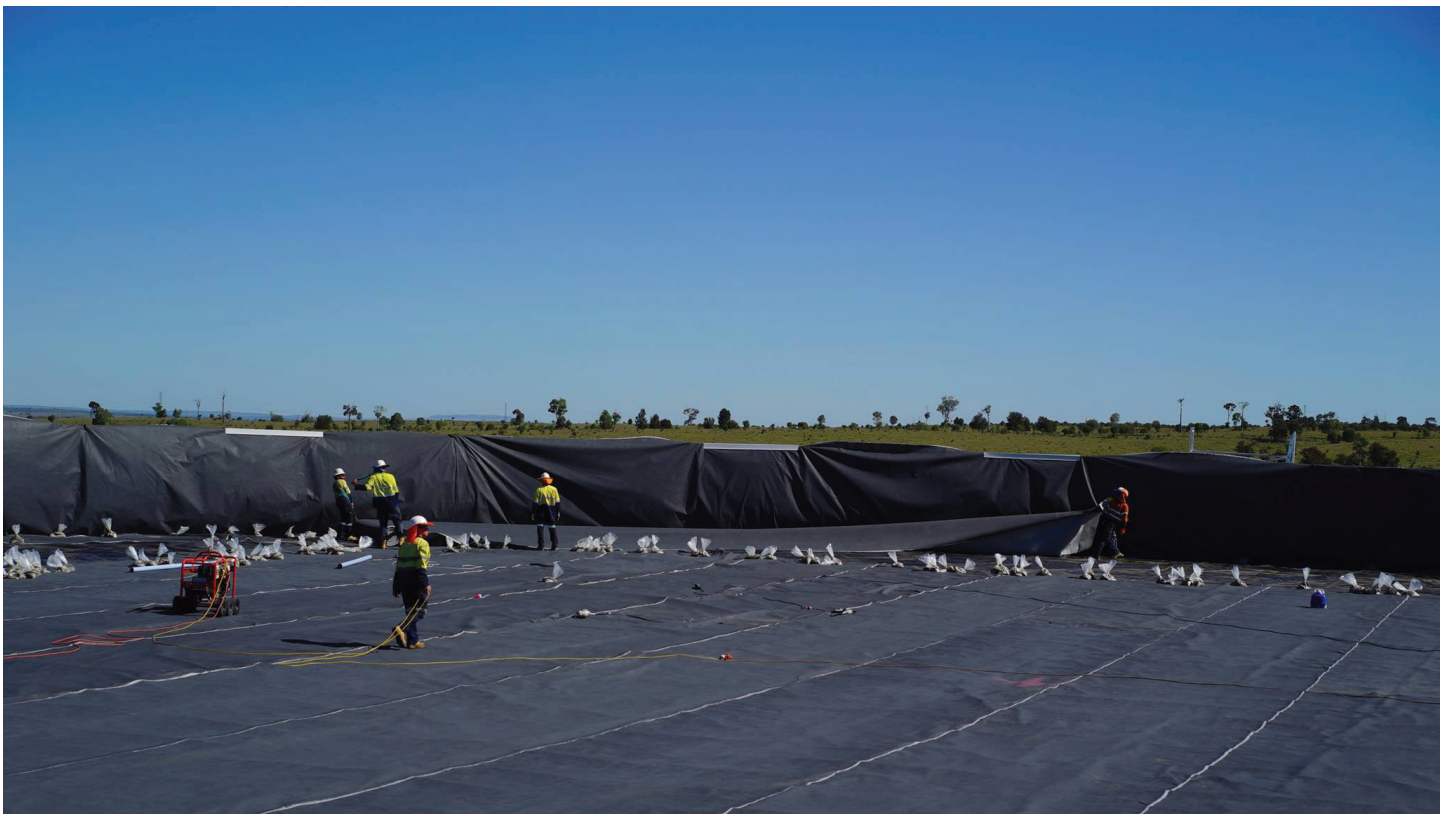
INSTALLING BIDIM C

On this project the client elected to weld the bidim C panels together in lanes to prevent shifting of the geotextile when the large geomembrane panels were dragged across. In other applications where geomembrane will be rolled across the bidim C a simple 10 mm overlap is all that is required to deliver the conductivity required for leak detection testing.
